Repairhints

Service-Level 3 & 4

3510 / 3510i

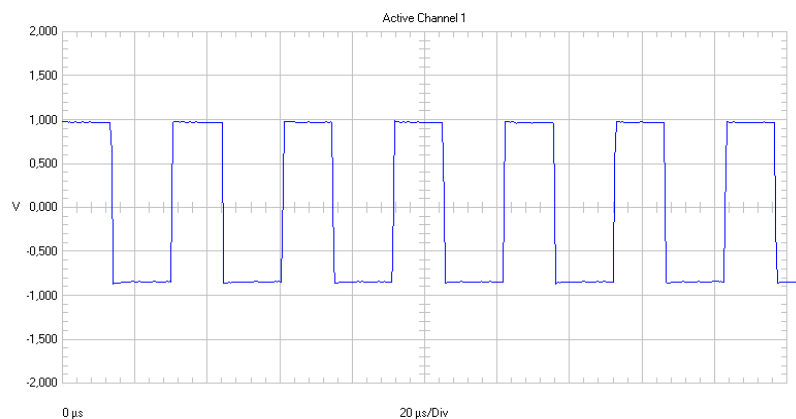
Figure 5: Sleepclock at J404

- VIO 1.8VDC at C400
- VCORE 1.5VDC at C451
- SLEEPCLK 32kHz at J404
- 26MHz system clock at J425
- PURX 1.8VDC at J403
- If one of the above mentioned signals is not measurable probably UEM is faulty; swap the phone as UEM is not changeable. The only exception is a missing system clock – in this case check B600 and N600.
- If signals are okay try to flash the phone A failure message C101 or C102 from prommer box indicates that D200 or D400 is defect in all probability. In case of failure message C586 the problem may be solved by changing the Flash D450.

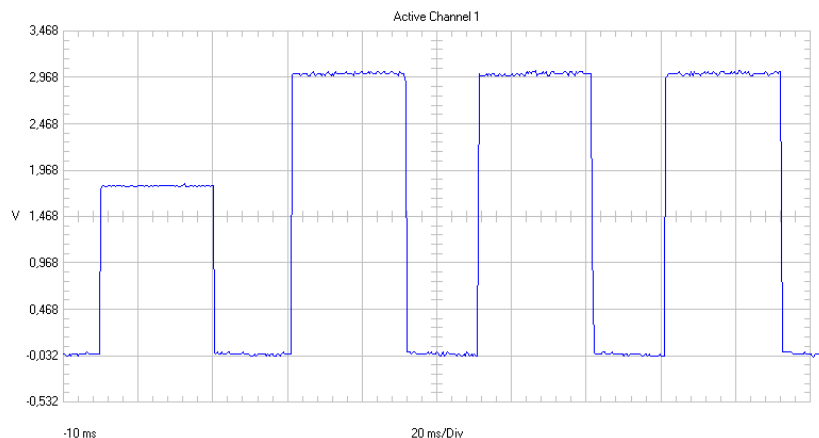
Figure 7: VSIM

- If fault persists and mechanical appearance of SIM reader seems to be ok, check with oscilloscope if SIM lines at SIM reader pins 1-4 are pulses to 1.8V / 3V as shown in the chart below (Phone switched on without SIM card). Signals are slightly different between pins 1-4 but the amplitude always is 1.8V / 3V.

In case that the above mentioned signal is not measurable at one or more SIM lines, check SIM lines for shorts to ground. Resistance of SIM data- and VSIM line normally is > 200kOhm, resistance of SIM reset- and SIM clock line normally is about 4.5MOhm.

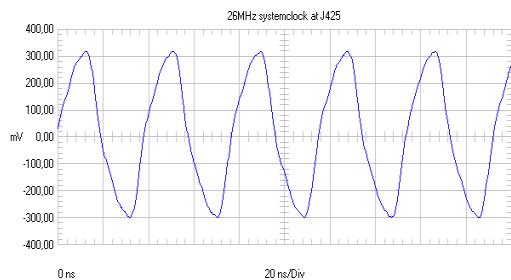
Figure 8: 26MHz at J425

- Check supply voltages VR1A 4.7VDC at both sides of R603, VR2 2.8VDC at C612, VR3 2.8VDC at C618, VR5 2.8VDC at C614, VR6 2.8VDC at C610, VR7 2.8VDC at C624, VIO 1.8VDC at C621 and VREF01 1.35VDC at C626.
- Check 26MHz reference clock at J425. Unfortunately it is not possible to check the signal of the SHF-oscillator directly, but you can check the control voltage at C641: if this voltage is outside its normal range (1.2VDC up to 3.2VDC) this indicates that the oscillator probably is faulty or the control loop is open. Further more check ResetX_Mjoelner at R604, which normally is 1.8VDC.

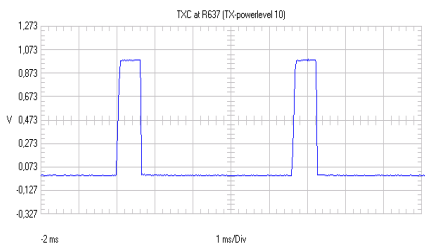
Figure 9: TXC at R637

- Check with an oscilloscope TXC at R637 (0.7Vpp – 1.8Vpp depending on TX-powerlevel), TXP 1.8Vpp at C646 and TX/IQ-signals at both sides of C627/628:

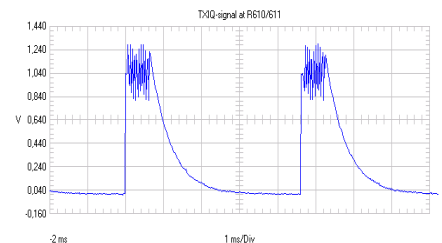
Figure 11: TXIQ at R610/611

If all these signals are ok but no TX-signal is measurable at L606 (L604 in GSM1800), Mjoelner N600 is faulty in all probability.

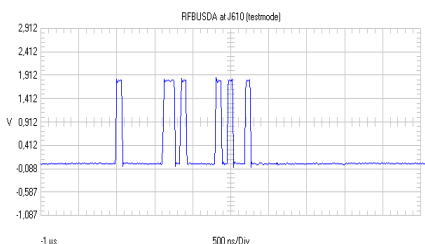
Figure 12: RFBUSData at J610

- Check with an oscilloscope RFBUSData at J610, RFBUSClk at J608 and RFBUSEnable at J609:

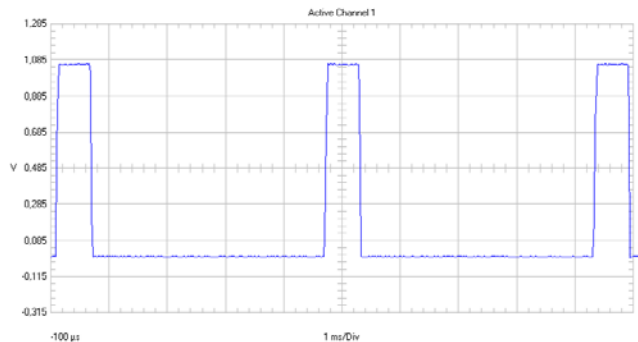
Figure 15: VPCTRL_G at R713

- Check VBATT 4VDC at both sides of L703
- Check VPCTRL_G 0.8Vpp – 1.4Vpp dependent on TX powerlevel at R713 (GSM 1800: VPCTRL_P at R708)

If the signal at the amplifier's input at R714 (GSM 1800: R711) and the above mentioned signals are ok but still there is no or too low TX power at the amplifier's output, it is necessary to exchange N700. Remember to perform RF-calibrations after having exchanged the power amplifier.

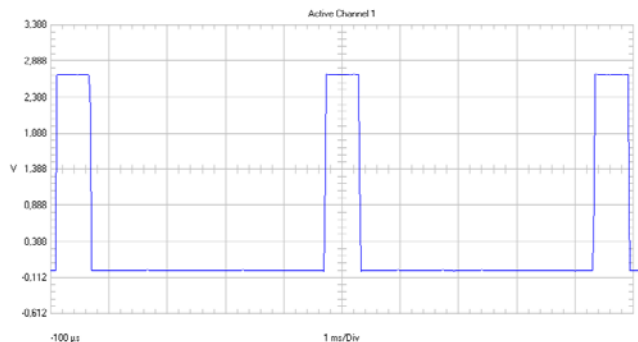
Figure 16: VTX_B_G at R717

- Check VTX_B_G 2.7Vpp at R717 (GSM 1800: VTX_B_P at R719)

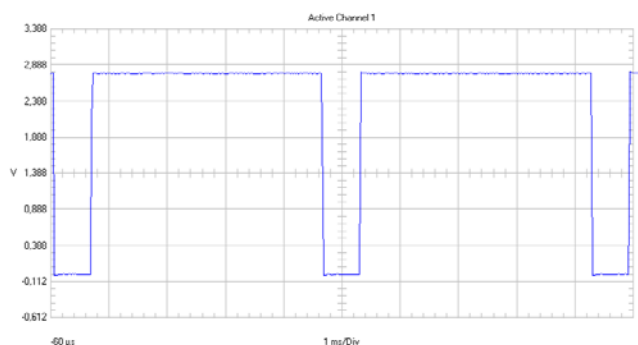
Figure 17: VTXLO_G at R716

- Check VTXLO_G 2.7Vpp squarewave in GSM 900 TX powerlevel 5 & 6 at R716. If TX powerlevel is 7 or lower signal at R716 is 2.7VDC. (For GSM 1800 switching between high/low mode is not available)
